# FIND THE LEAKING SEAMS INSPECTING HEAT SEALED PACKAGES

# CASE: INSPECTING BERGADER PRIVATKÄSEREI HEAT SEALED PACKAGES WITH SPECIM FX17

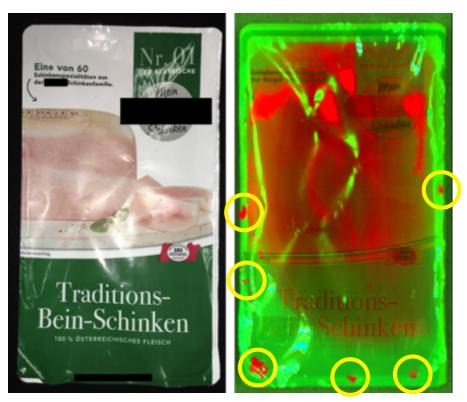
Inspection result with SPECIM FX17, contaminations in the seal marked with a yellow circle

### SPECIM FX17 camera inspects the seal through a printed film

- Detection through transparent and colored/printed plastics, only method that works even through printed plastics
- On-line and real-time 100% inspection coverage
- Only imaging technique to reliably find imperfect seals
